PENHALONGA

COMMUNITY ENVIRONMENTAL AUDIT REPORT

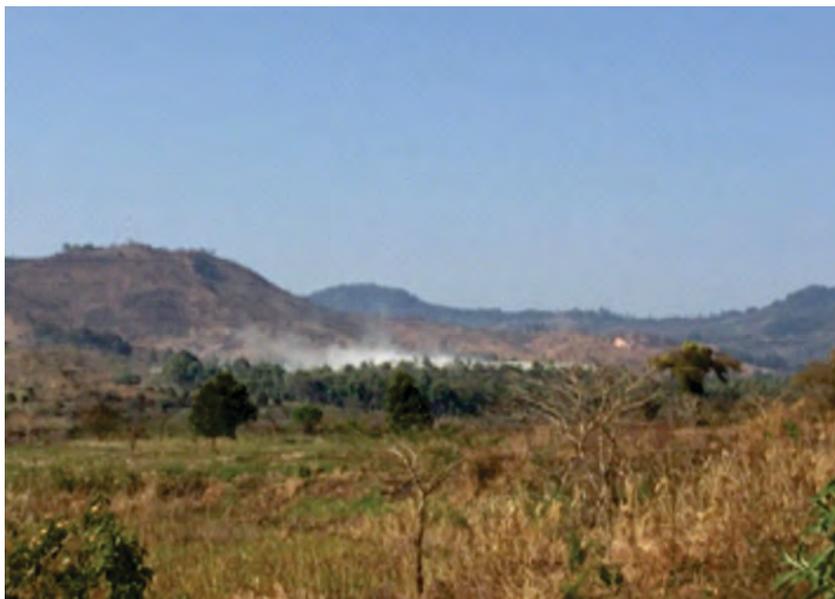
Redwing's mine operations have resulted in the formation of large mine dumps. These hill-like dumps have accumulated over a number of years from the residue of gold mining. The residue, called tailings, is a very fine and thin sand-like material, which is a mixture of crushed rock, metals and other materials used to process the gold.

These dumps have been a continuing source of air pollution, especially to those households in close proximity to the dumps. Some households are as close as 500 metres. During windy conditions the levels of dust pollution become unbearable for approximately 700 families in the community.

Figure 5: Dust rising from one of the mine dumps

- The continued clearing of the mine dumps so they are not permitted to reach over 3 meters height. A wall or enclosure should be erected to prevent dust escaping from the area.
- Use a dust suppressant on the surface of the dumps. Any suppressant should stop the dust from rising but not end up flowing and damaging the soil and water sources.
- The soil on the mine dumps has to be reclaimed in-order to remove any chemicals from the soil so as to allow the soil to sustain any vegetation as it did prior to mining.

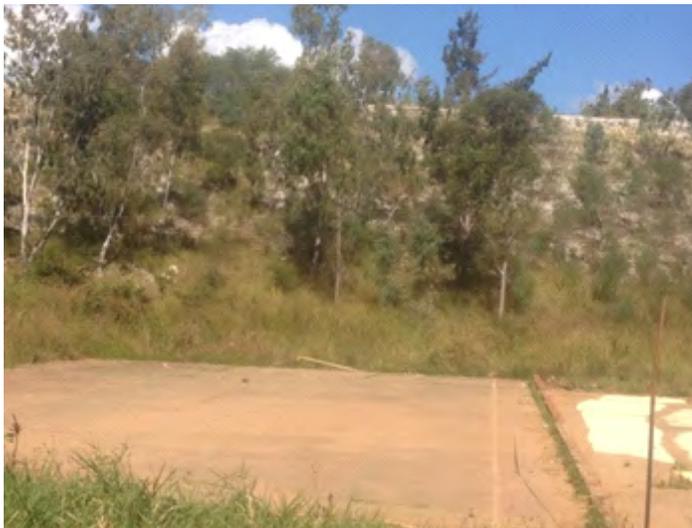
Figure 6: An unrehabilitated mine dump just near

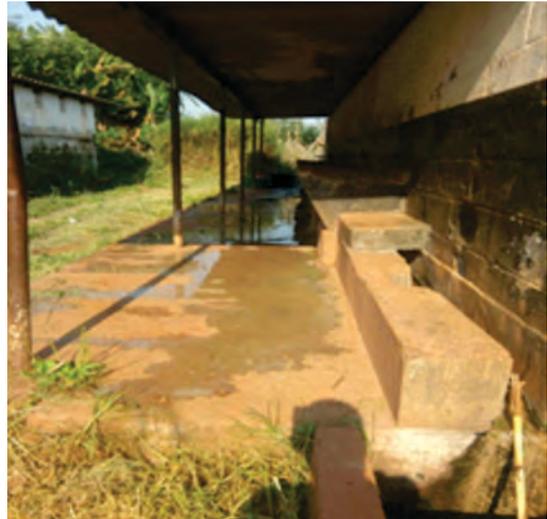
Figure 7: Redwing mine toilets flowing raw sewage

Further, the mine is failing to contain its waste system resulting in sewage running off into the river. The sewage spills into the Mutare River and Nyahuku River, which is connected to the Mutare River.

- Redwing should maintain a closed system of their mine operations to prevent any spillage of chemicals into the community's river.
- The mine should repair its sewage system so that it does not drain into the river.
- The Agency to ensure that the company has all necessary licenses to operate.

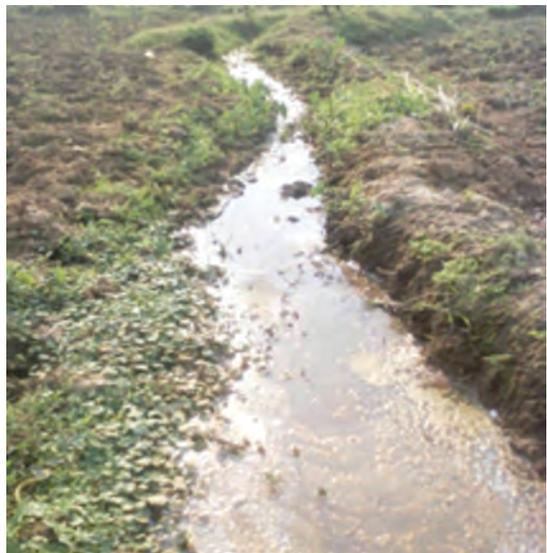
Figure 8: Raw sewage from Redwing Mine toilets flowing in the river

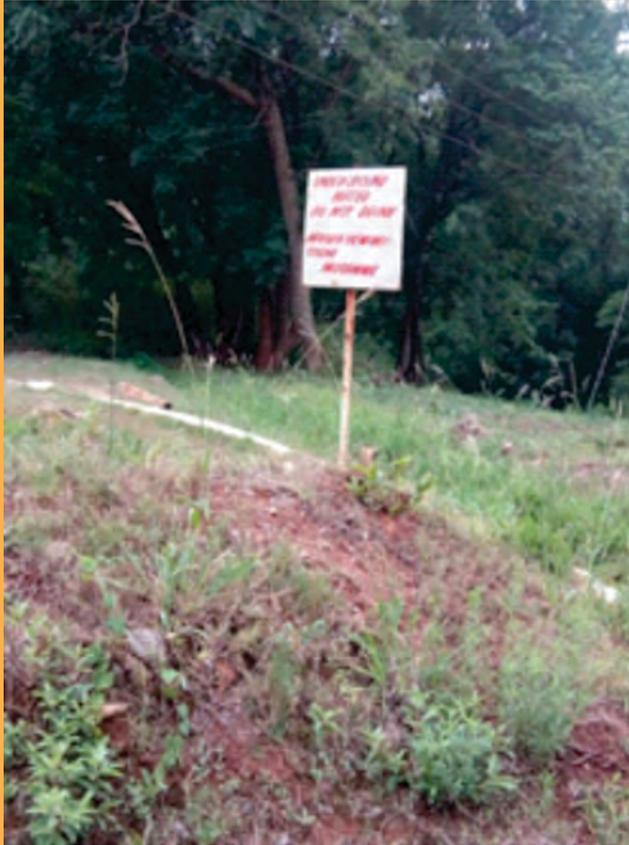
The audit team noted various water points where water used by the mine is discharged directly into the Mutare River. Some of these discharge points have been marked by signs warning the public not to drink the water in the River.

Figure 9: A sign warning the community not to drink any underground water

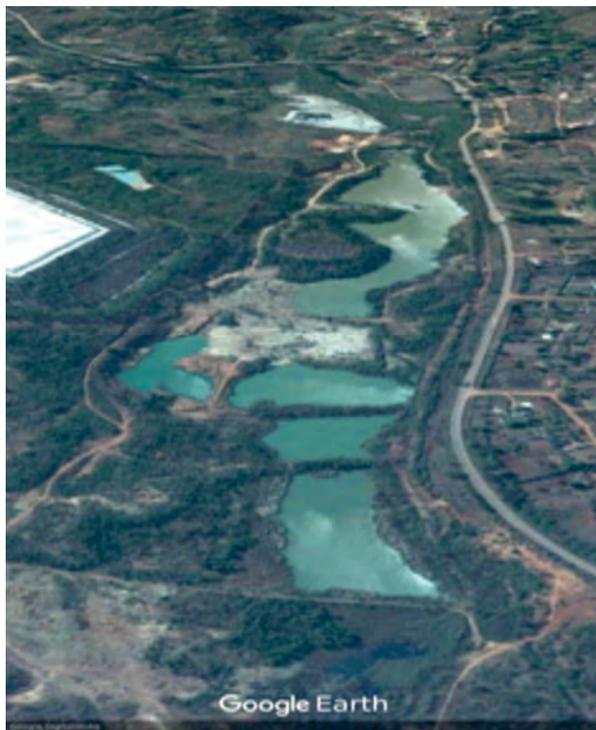
To carry out its mining activities, DTZ-OZGEO restricted the flow of the Mutare River at a number of points. These impoundments created artificial dams and badly affected the flow of water along the River. These are clearly visible in Figure 10.

Figure 10: Google image showing water impoundment by DTZ OZGEO in Mutare River

- The Mutare River should be rehabilitated by removing the artificial soil barricades placed in the river to make artificial dams. Should the Agency be unable to force the company to undertake rehabilitation activities, the Environmental Fund should be utilized to restore the degraded environment.

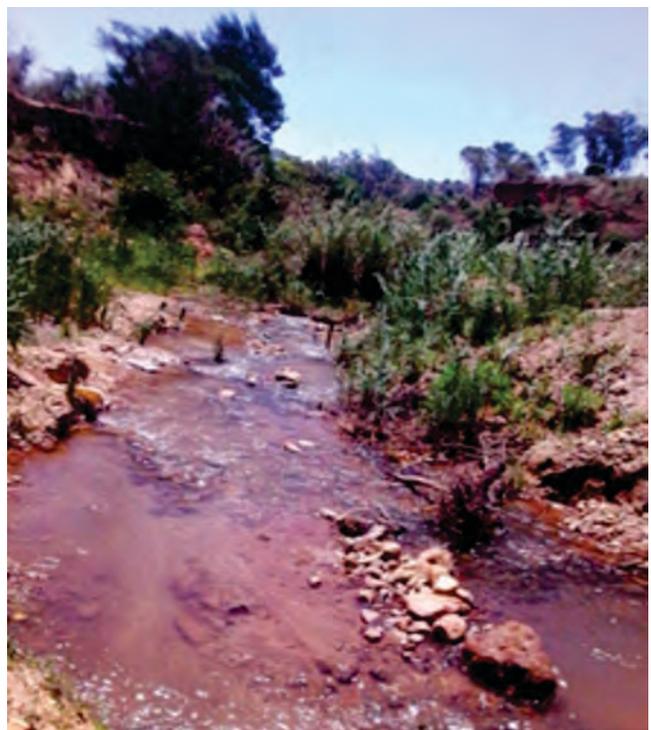
Figure 11: Impoundments by DTZOZGEO still affect the water flow in Mutare River

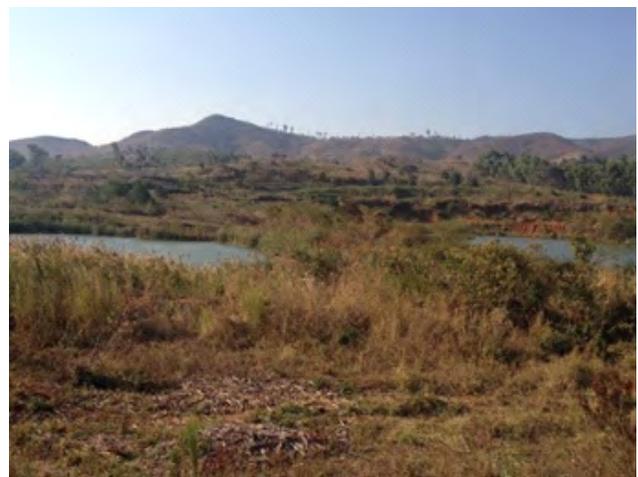
Mining by the company changed Mutare River's water course more than ten times. While there have been no scientific assessments carried out to determine the damage done to the ecosystem as a result of these actions the geophysical impacts of this remain evident. A number of sections of the Mutare River remain unrehabilitated.

Figure 12: Unrehabilitated water impoundments by DTZ OZGEO

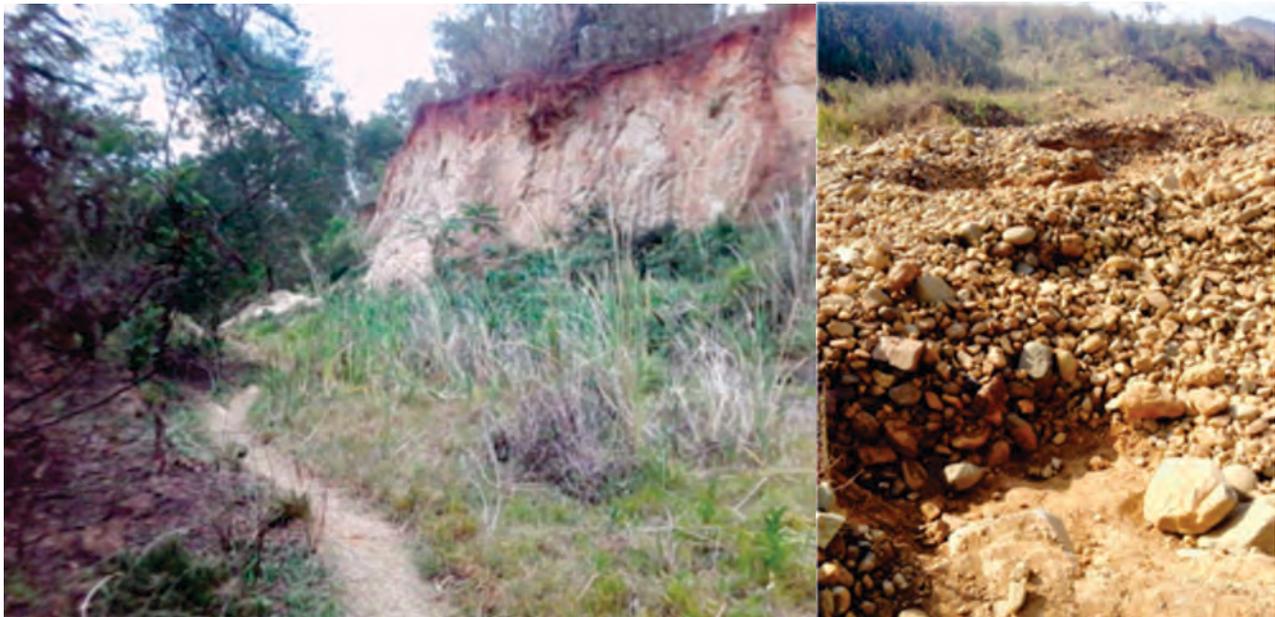
Figure 13 and 14: Unrehabilitated land abandoned by DTZ OZGEO

In 2016, one community member drowned after falling in one of the pits. The open trenches are now the target of artisanal gold miners who flocked to the area after DTZ OZGEO's departure. This is a significant safety risk, as there are reports of miners dying after falling in the pits, and also the cause of further environmental degradation to the area.

- The land area impacted by mining activities should be rehabilitated to allow vegetation to grow. The gullies and pits should be filled.

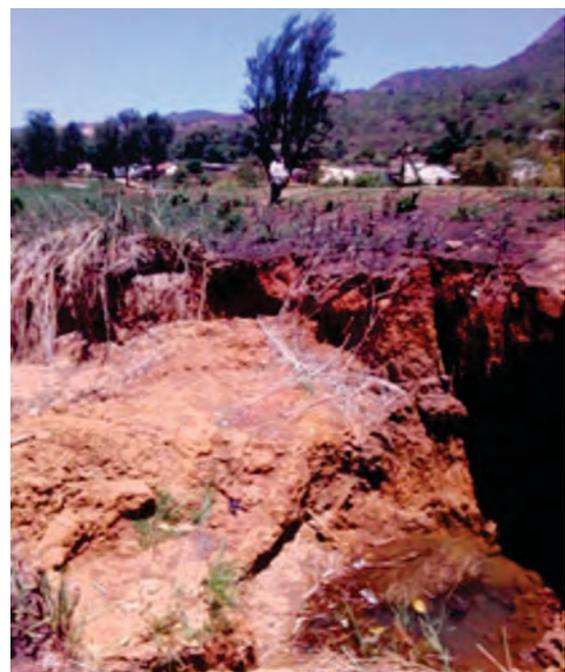
Figure 15: Unrehabilitated gullies abandoned by DTZOZGEO prone to artisanal miners

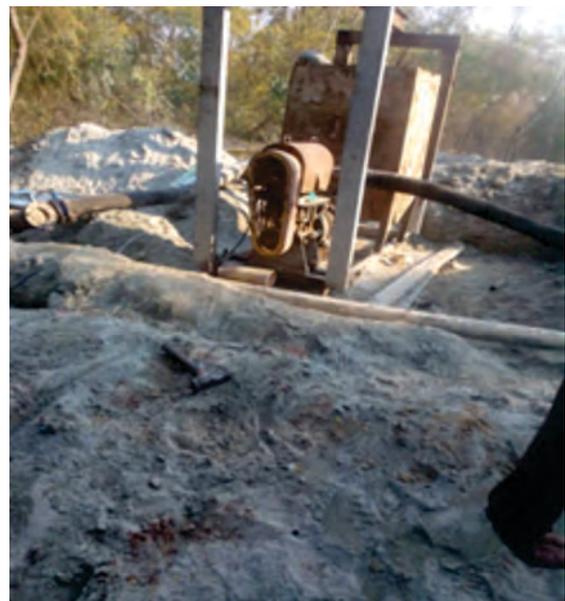
Figure 16: Water pump bought by Redwing Mine to remedy the dust pollution after the community lodged dust complaints with the Agency

During the Audit process, affected community members filed complaints with the Agency regarding the dust pollution. A section of the letter is included in Annex 1. As a result, the Agency ordered the mine to deal with the complaint. The company now sprays the mine dumps with water. However, spraying the mine dumps with a suppressant is not an effective long-term remedy for stopping the dust. The community members also remain concerned about the water run-off causing further pollution.
